**Flood Control Project Maintenance  
Levee Inspections**

## Maintenance Issue Types Only, Levee Inspection Report By Mile - Spring 2019

### Reclamation District No. 2063 Crows Landing

Waterway	Bank	Unit Miles	Inspection Start/End	Inspector
Unit No. 01 San Joaquin River	Right	10.44	04/17/2019 04/17/2019	Corey Fujitani

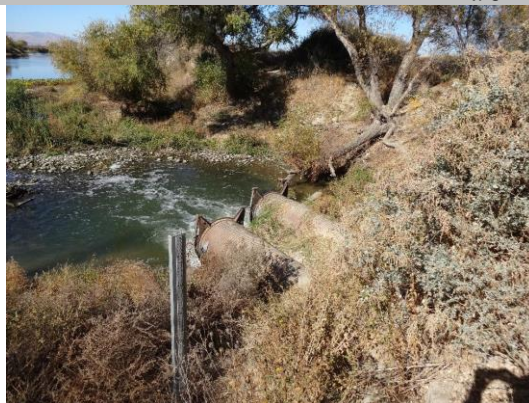
Photo 1 of 3 : UCIP\_SP\_2019\_50218\_43204.jpg

Comment Code					
Inspector Comment					
FS_ID:50218					
DS_ID:22076					
EP_NO: N/A					
Repair Type: No Action Needed					
Crossing Status: Found					
UCIP Comments: 08/23/2016: WS flapgates were held open by a piece of wood. Pipes may be used temporarily for irrigation. (K. Fazel - UCIP)11/05/2013: working during the inspection. (P. Amatya - DWR)					
FIELD_STRUCT_DESC: [Lateral Drain No. 5] 1 of 2: 48-inch corrugated metal gravity drainage pipe through the levee, 25.5 feet below the crown. Slide gate in a corrugated metal pipe (CMP) riser on the waterside (WS) slope. Flap gate on the WS end. 70-foot-long cobble spillway to river. Installed by USACE in 1961. [Additional Reference(s): DWR Levee Log, 1992. USACE San Joaquin O&M Manual 6, September 1961, (HLM 1.35)].					
FS Date: 11/5/2013

WS view: two outfall CMP pipes on levee slope.

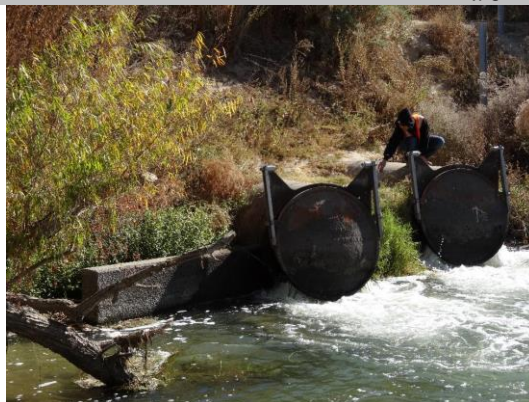
Photo 2 of 3 : UCIP\_SP\_2019\_50218\_43203.jpg

WS view: two outfall CMP pipes with flap gates on concrete headwall.

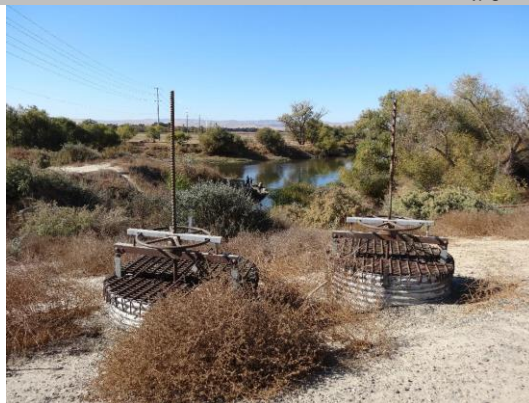
Photo 3 of 3 : UCIP\_SP\_2019\_50218\_43202.jpg

WS view: two slide gates in CMP risers on levee slope.

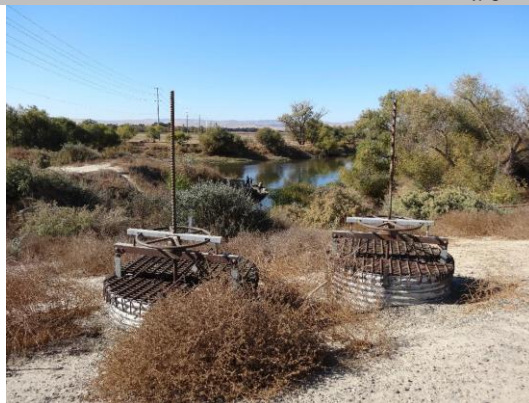
Photo 1 of 3 : UCIP\_SP\_2019\_50217\_43217.jpg

Comment Code					
Inspector Comment					
FS_ID:50217 DS_ID:22119 EP_NO: N/A Repair Type: No Action Needed Crossing Status: Found UCIP Comments: 08/23/2016: WS flapgates were held open by a piece of wood. Pipes may be used temporarily for irrigation. (K. Fazel - UCIP)11/05/2013: working during field inspection. (P. Amatya - DWR) FIELD_STRUCT_DESC: [Lateral Drain No. 5] 2 of 2: 48-inch corrugated metal gravity drainage pipe through the levee, 25.5 feet below the crown. Slide gate in a corrugated metal pipe (CMP) riser on the waterside (WS) slope. Flap gate on the WS end. 70-foot-long cobble spillway to river. Installed by USACE in 1961. [Additional Reference(s): DWR Levee Log, 1992. USACE San Joaquin O&M Manual 6, September 1961, (HLM 1.35)]. FS Date: 11/5/2013

WS view: two CMP risers with slide gates on levee slope.

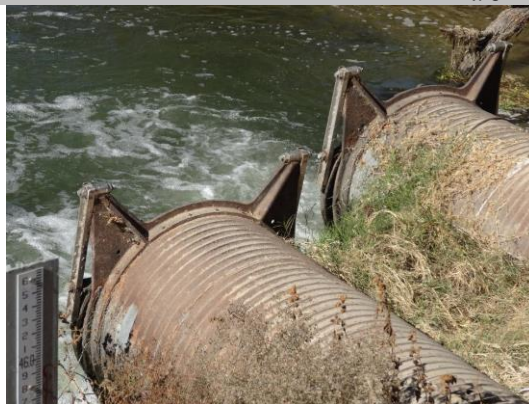
Photo 2 of 3 : UCIP\_SP\_2019\_50217\_43216.jpg

WS view: two CMP outfall pipes with flap gates on levee slope.

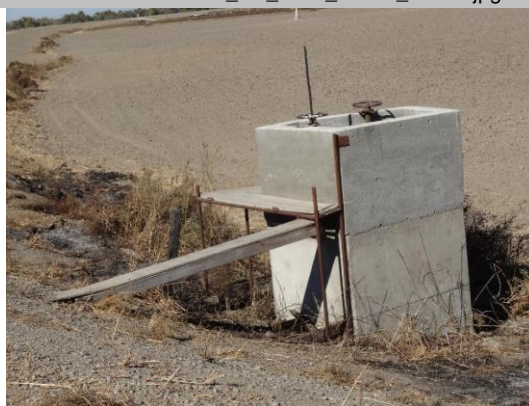
Photo 2 of 3 : UCIP\_SP\_2019\_51823\_43347.jpg

Comment Code						
Inspector Comment						
FS_ID:51823						
DS_ID:22081						
EP_NO: N/A						
Repair Type: No Action Needed						
Crossing Status: Found						
UCIP Comments: 11/05/2013 - concrete standpipe on waterside toe.- concrete distribution box on landside.- an alfalfa valve on waterside toe. (P. Amatya - DWR UCIP)						
FIELD_STRUCT_DESC: 30-inch corrugated metal gravity drainage pipe through the levee, 12 feet below the crown. Flap gate on the waterside (WS) end. Slide gate in a concrete distribution box on the landside (LS) end. Concrete U-shaped headwall on the WS end. [Additional Reference(s): DWR Levee Log, 1992. USACE San Joaquin O&M Manual 6, September 1961, (HLM 2.29)].						
FS Date: 11/5/2013

LS view: concrete distribution box and temporary walkway on levee toe.

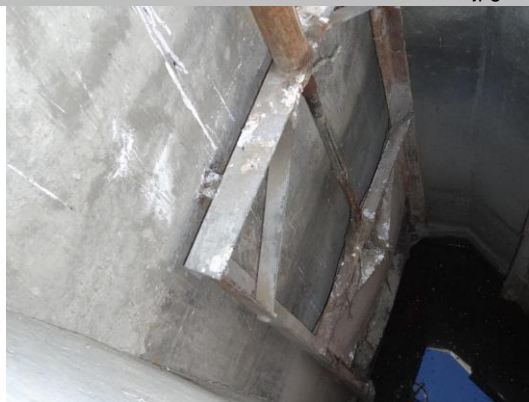
Photo 3 of 3 : UCIP\_SP\_2019\_51823\_43346.jpg

LS view: slide gate in concrete distribution box.

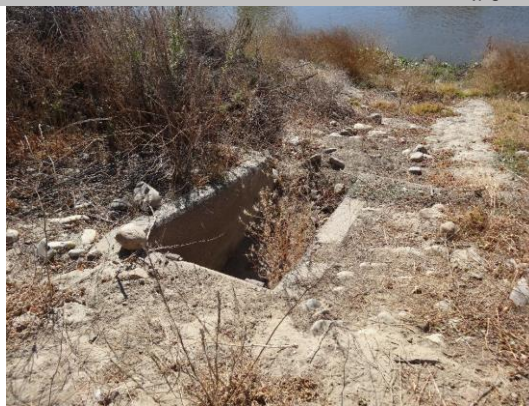
Photo 1 of 3 : UCIP\_SP\_2019\_24435\_43484.jpg

LM Start	2.62	Rating **	M	Issue No.	65
LM End	2.62	Issue Type +	Ma	Location *	
Category	Supplemental			GPS Latitude/Longitude	
				Start	End
Item	DWR UCIP LMA Responsibility			37.448233 °	37.448233 °
				-121.026521 °	-121.026521 °
DWR ID	22086				
Comment Code					
Inspector Comment					
FS_ID:24435 DS_ID:22086 EP_NO: N/A Repair Type: Non-Urgent Crossing Status: Found UCIP Comments: 11/05/2013 Both pipe ends 70 ft off the levee center.Clearing and cleaning of inlet/outlet pipe needed. (P. Amatya - DWR UCIP) FIELD_STRUCT_DESC: 24-inch corrugated metal gravity drainage pipe through the levee, 12 feet below the crown. Flap gate on the waterside (WS) end. Concrete headwall on each end. Installed by USACE in 1961. [Additional Reference(s): DWR Levee Log, 1992. USACE San Joaquin O&M Manual 6, September 1961, (HLM 2.65)]. FS Date: 11/5/2013

WS view: U shaped headwall outlet structure 70 ft off the levee center.

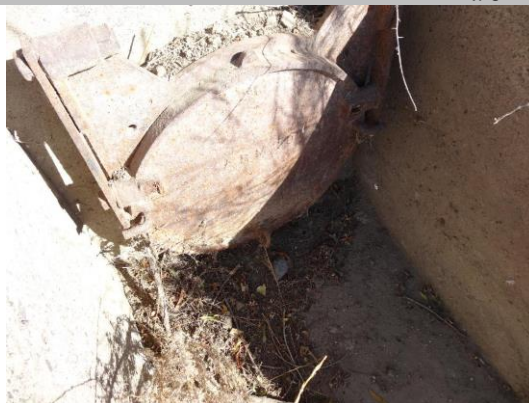
Photo 2 of 3 : UCIP\_SP\_2019\_24435\_43483.jpg

WS view: U shaped headwall outlet structure and pipe with flap gate.

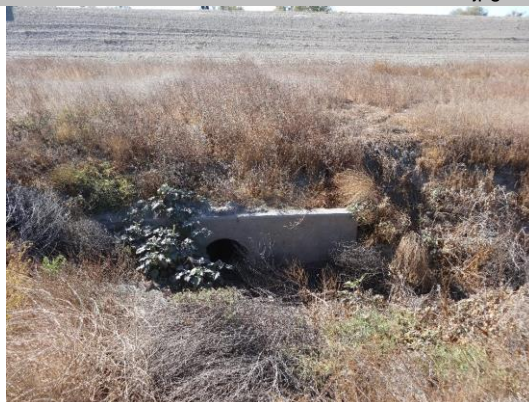
Photo 3 of 3 : UCIP\_SP\_2019\_24435\_43482.jpg

LS view: concrete headwall with CMP 70 ft off the levee center.

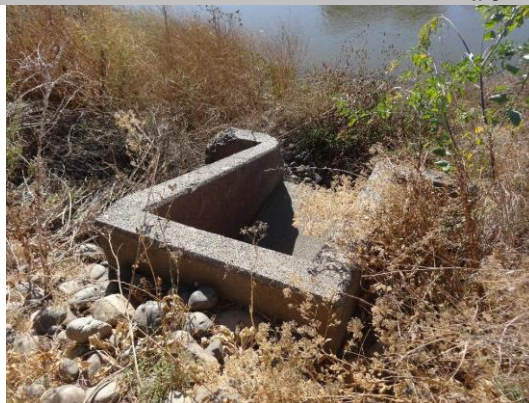
Photo 1 of 3 : UCIP\_SP\_2019\_25023\_45102.jpg

LM Start	2.68	Rating **	A/W	Issue No.	66
LM End	2.68	Issue Type +	Ma	Location *	
Category	Supplemental			GPS Latitude/Longitude	
				Start	End
Item	DWR UCIP LMA Responsibility			37.447475 °	37.447475 °
				-121.026017 °	-121.026017 °
DWR ID	22087				
Comment Code					
Inspector Comment					
FS_ID:25023 DS_ID:22087 EP_NO: N/A Repair Type: No Action Needed Crossing Status: Found UCIP Comments: 11/05/2013 Both pipe ends about 85 feet off the levee center. (P. Amatya - DWR UCIP) FIELD_STRUCT_DESC: 24-inch corrugated metal gravity drainage pipe through the levee, 20.3 feet below the crown. Flap gate on the waterside (WS) end. Concrete headwall on each end. Installed by USACE in 1961. [Additional Reference(s): DWR Levee Log, 1992. USACE San Joaquin O&M Manual 6, September 1961, (HLM 2.71)]. FS Date: 11/5/2013

WS view: U typed concrete headwall on river bank.

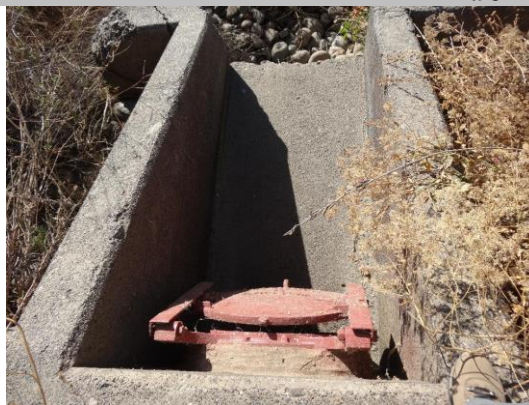
Photo 2 of 3 : UCIP\_SP\_2019\_25023\_45101.jpg

WS view: pipe, flap gate, and concrete headwall on river bank.

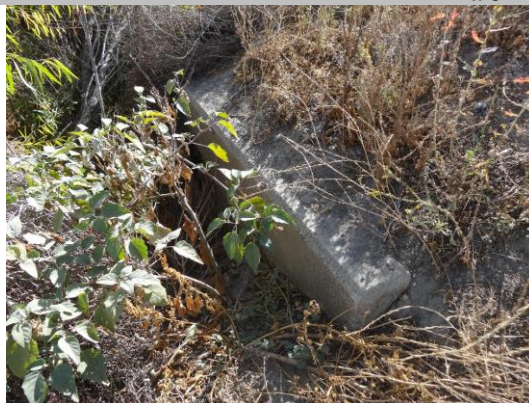
Photo 3 of 3 : UCIP\_SP\_2019\_25023\_45100.jpg

LS view: pipe and concrete headwall off the levee toe.

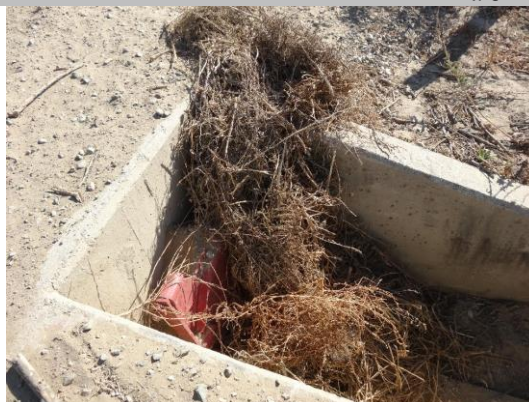
Photo 1 of 3 : UCIP\_SP\_2019\_24443\_43522.jpg

LM Start	2.93	Rating **	M	Issue No.	67
LM End	2.93	Issue Type +	Ma	Location *	
Category	Supplemental			GPS Latitude/Longitude	
				Start	End
Item	DWR UCIP LMA Responsibility			37.443871 °	37.443871 °
				-121.025775 °	-121.025775 °
DWR ID	22088				
Comment Code					
Inspector Comment					
FS_ID:24443					
DS_ID:22088					
EP_NO: N/A					
Repair Type: Non-Urgent					
Crossing Status: Found					
UCIP Comments: 11/05/2013 - clear and clean debris (P. Amatya - DWR UCIP)					
FIELD_STRUCT_DESC: *ABANDONED* 24-inch corrugated metal gravity drainage pipe through the levee, 9.5 feet below the crown. Flap gate on the waterside (WS) end. Pipe open on the landside (LS) end. Concrete headwall on each end. [Additional Reference(s): DWR Levee Log, 1992. USACE San Joaquin O&M Manual 6, September 1961, (HLM 2.97)].					
FS Date: 11/5/2013

WS view: U typed concrete headwall on levee slope.

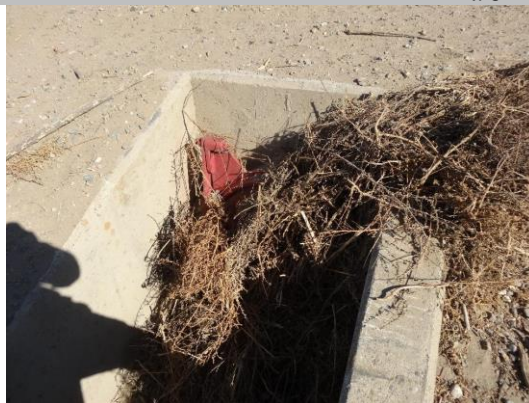
Photo 2 of 3 : UCIP\_SP\_2019\_24443\_43521.jpg

WS view: pipe, flap gate, and concrete headwall with debris blocking the outlet.

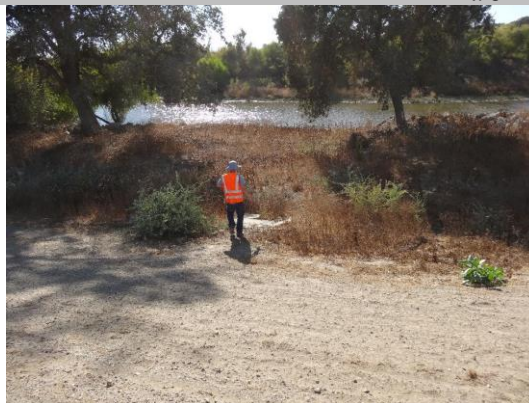
Photo 1 of 3 : UCIP\_SP\_2019\_24469\_43645.jpg

LM Start	3.29	Rating **	M	Issue No.	68
LM End	3.29	Issue Type +	Ma	Location *	
Category	Supplemental			GPS Latitude/Longitude	
				Start	End
Item	DWR UCIP LMA Responsibility			37.441213 °	37.441213 °
				-121.021130 °	-121.021130 °
DWR ID	22089				
Comment Code					
Inspector Comment					
FS_ID:24469 DS_ID:22089 EP_NO: N/A Repair Type: Non-Urgent Crossing Status: Found UCIP Comments: 11/05/2013 - cleaning required in inlet pipe.- new flap gate (P. Amatya - DWR UCIP) FIELD_STRUCT_DESC: *ABANDONED* 24-inch corrugated metal gravity drainage pipe through the levee, 12.5 feet below the crown. Flap gate on the waterside (WS) end. Concrete headwall on each end. [Additional Reference(s): DWR Levee Log, 1992. USACE San Joaquin O&M Manual 6, September 1961, (HLM 3.33)]. FS Date: 11/5/2013

WS view: U typed concrete headwall on levee toe

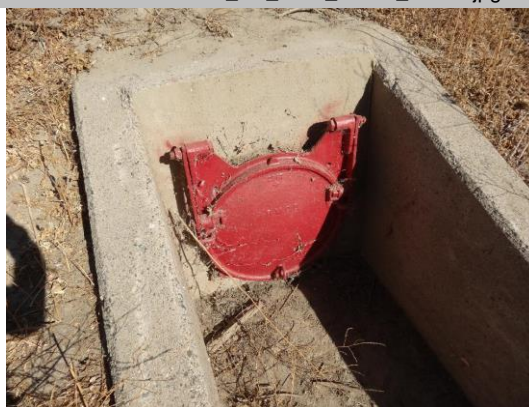
Photo 2 of 3 : UCIP\_SP\_2019\_24469\_43644.jpg

WS view: new flap gate, and U typed concrete headwall.

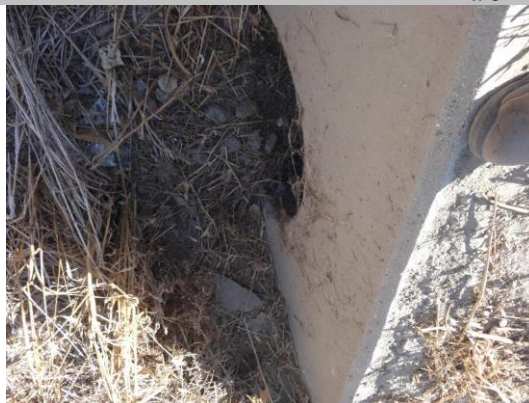
Photo 3 of 3 : UCIP\_SP\_2019\_24469\_43643.jpg

LS view: CM pipe and concrete headwall on levee slope. Debris blocking inlet pipe.

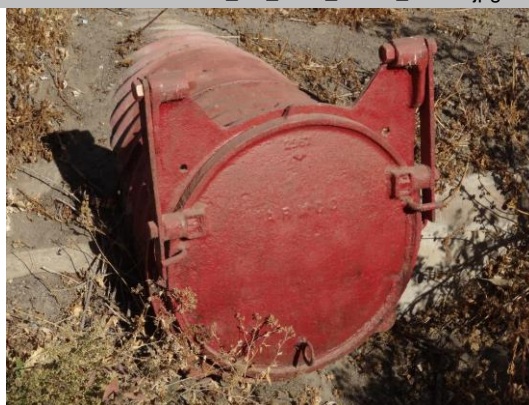
Photo 1 of 3 : UCIP\_SP\_2019\_24485\_43667.jpg

LM Start	3.64	Rating **	M	Issue No.	69
LM End	3.64	Issue Type +	Ma	Location *	
Category	Supplemental			GPS Latitude/Longitude	
				Start	End
Item	DWR UCIP LMA Responsibility			37.436845 °	37.436845 °
				-121.017826 °	-121.017826 °
DWR ID	22093				
Comment Code					
Inspector Comment					
FS_ID:24485 DS_ID:22093 EP_NO: N/A Repair Type: Non-Urgent Crossing Status: Found UCIP Comments: 11/05/2013 - new flap gate on waterside.- cleaning and clearing of inlet box needed. (P. Amatya - DWR UCIP) FIELD_STRUCT_DESC: 24-inch corrugated metal gravity drainage pipe through the levee, 12 feet below the crown. Flap gate and concrete saddle on the waterside (WS) end. Concrete drop inlet box on the landside (LS) end. Installed by USACE in 1961. [Additional Reference(s): DWR Levee Log, 1992. USACE San Joaquin O&M Manual 6, September 1961, (HLM 3.69)]. FS Date: 11/5/2013

WS view: pipe, flap gate, and concrete saddle on levee slope

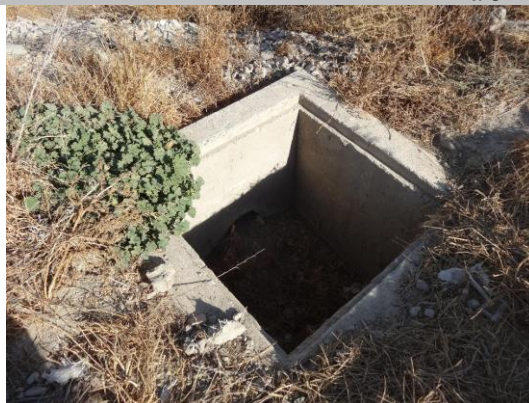
Photo 2 of 3 : UCIP\_SP\_2019\_24485\_43666.jpg

LS view: concrete drop inlet box on levee toe.

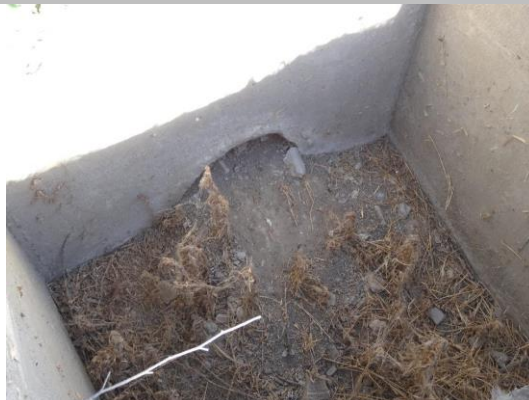
Photo 3 of 3 : UCIP\_SP\_2019\_24485\_43665.jpg

LS view: inside view of inlet box on levee toe. Debris blocking inlet pipe.

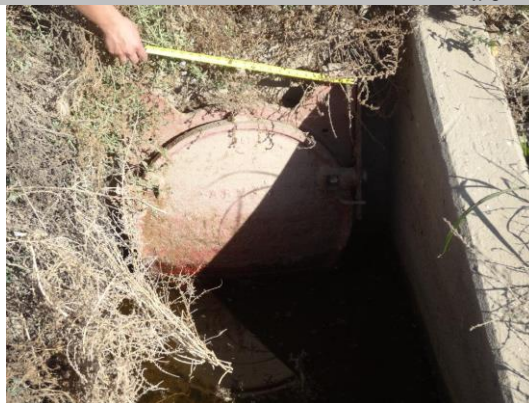
Photo 1 of 3 : UCIP\_SP\_2019\_51821\_43842.jpg

Comment Code					
Inspector Comment					
FS_ID:51821					
DS_ID:22096					
EP_NO: N/A					
Repair Type: No Action Needed					
Crossing Status: Found					
UCIP Comments: 05/11/2017 Review of photos indicate less than 1/4 of the inlet is silted in. Since the pipe is in good condition, it has been downgraded from Non-Urgent to No Action Needed. (K. Fazel - UCIP)11/05/2013:- new flap gate on waterside.- cleaning of outlet and inlet pipes required. (P. Amatya - DWR)					
FIELD_STRUCT_DESC: 24-inch corrugated metal gravity drainage pipe through the levee, 12 feet below the crown. Flap gate on the waterside (WS) end. Concrete headwall on each end. Installed by USACE in 1961. [Additional Reference(s): DWR Levee Log, 1992. USACE San Joaquin O&M Manual 6, September 1961, (HLM 4.08)].					
FS Date: 11/5/2013

WS view: pipe, flap gate, and concrete headwall on drainage ditch.

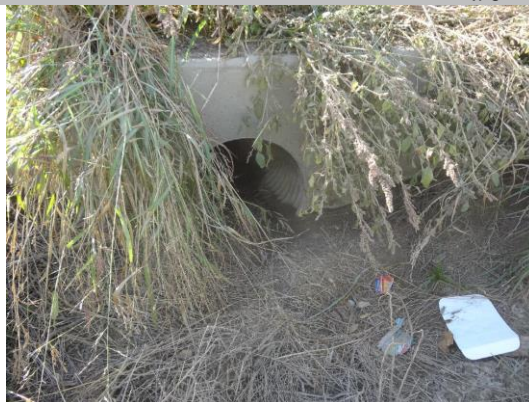
Photo 2 of 3 : UCIP\_SP\_2019\_51821\_43841.jpg

LS view: CM pipe and concrete headwall on levee toe.

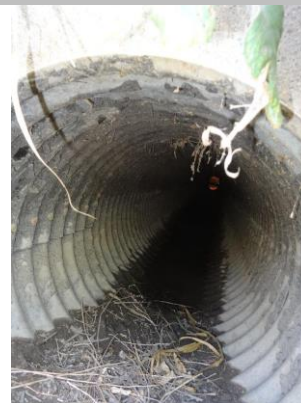
Photo 3 of 3 : UCIP\_SP\_2019\_51821\_43840.jpg

LS view: inside view of the CM pipe on levee toe.

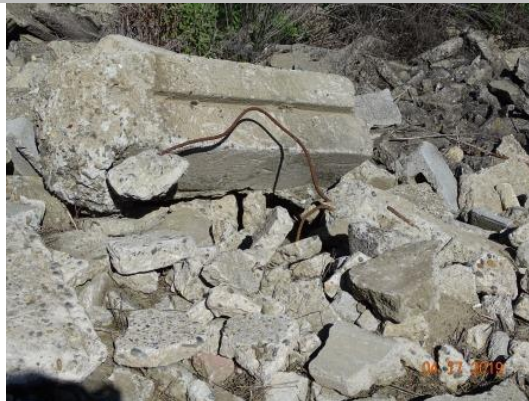
Photo 1 of 1 : SP\_2019\_RD2063\_112\_40\_20190501\_00111.jpg

Representative view of concrete rip rap used at this location. (Spring 2019)

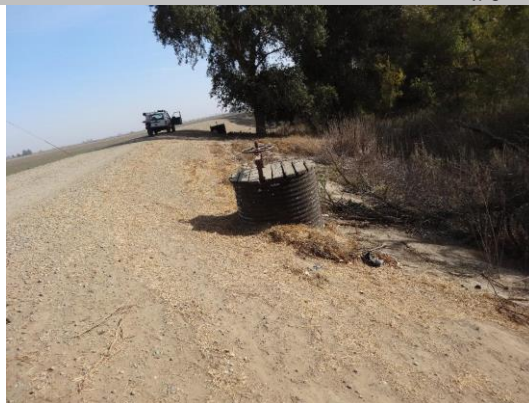
Photo 1 of 3 : UCIP\_SP\_2019\_24632\_43953.jpg

Comment Code						
Inspector Comment						
FS_ID:24632						
DS_ID:22110						
EP_NO: N/A						
Repair Type: No Action Needed						
Crossing Status: Found						
UCIP Comments: 11/06/2013 No pipe visible on landside.Flap gate through the levee, 25.5 feet below the crown. Slide gate in a corrugated not found on the waterside end. Concrete "U" headwalls not found on ends of pipe. (P. Amatya - DWR UCIP)						
FIELD_STRUCT_DESC: 36-inch corrugated metal gravity drainage pipe through the levee, 25.5 feet below the crown. Slide gate in a corrugated metal pipe (CMP) riser on the waterside (WS) slope. Flap gate on the WS end. Concrete U-shaped headwall on each end. Installed by USACE in 1961. [Additional Reference(s): DWR Levee Log, 1992. USACE San Joaquin O&M Manual 6, September 1961, (HLM 7.61)].						
FS Date: 11/6/2013

WS view: CMP riser on levee slope. No pipe visible on levee slope.

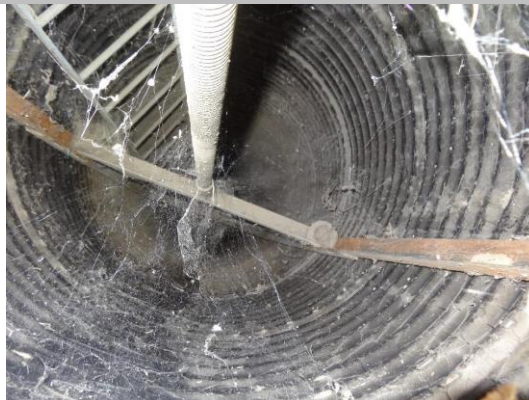
Photo 2 of 3 : UCIP\_SP\_2019\_24632\_43952.jpg

WS view: slide gate in CMP riser on levee slope.

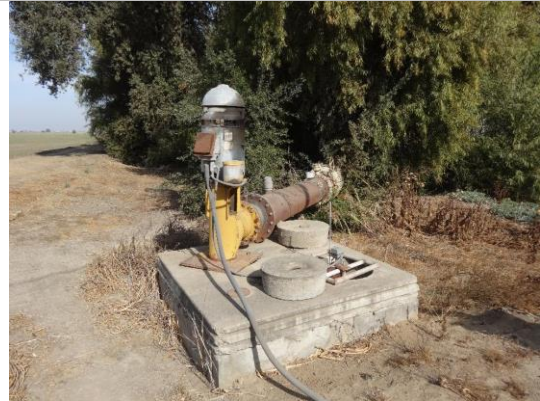
Photo 3 of 3 : UCIP\_SP\_2019\_24632\_43951.jpg

LS view: concrete distribution box on levee toe. Pump on the box discharges water into irrigation ditch.

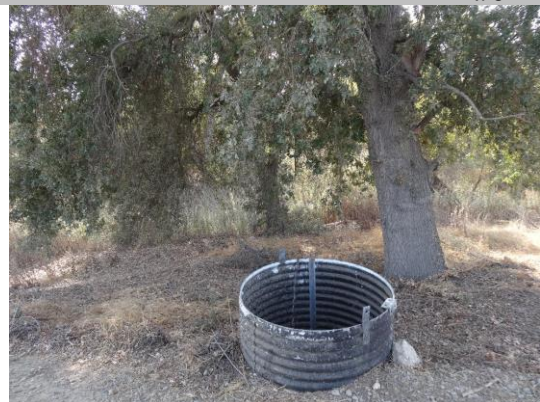
Photo 1 of 3 : UCIP\_SP\_2019\_25031\_45141.jpg

Comment Code						
Inspector Comment						
FS_ID:25031						
DS_ID:22111						
EP_NO: N/A						
Repair Type: Non-Urgent						
Crossing Status: Found						
UCIP Comments: 11/06/2013 Pump mounted on top of concrete pipe						
sump not found on the waterside. Concrete standpipe not found on						
the landward side.Looks abandoned. (P. Amatya - DWR UCIP)						
FIELD_STRUCT_DESC: *ABANDONED* 12-inch concrete encased						
steel drainage discharge pipe through the levee, 7 feet below the crown.						
Slide gate in a corrugated metal pipe (CMP) riser on the waterside (WS)						
slope. Pipe open on both ends. Installed by USACE in 1961. [Additional						
Reference(s): DWR Levee Log, 1992. USACE San Joaquin O&M						
Manual 6, September 1961, (HLM 7.62), 10-inch pipe referenced].						
FS Date: 11/6/2013

WS view: CMP riser with slide gate. Missing slide gate handwheel.

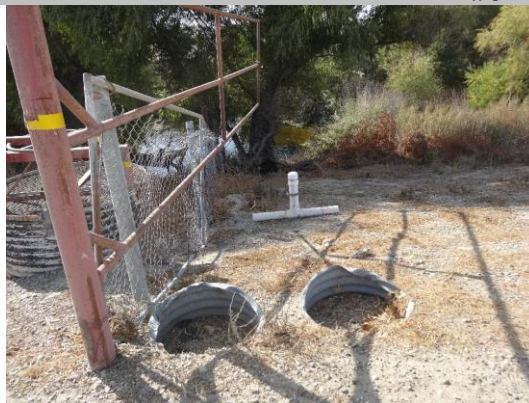
Photo 1 of 3 : UCIP\_SP\_2019\_24651\_44005.jpg

Comment Code						
Inspector Comment						
FS_ID:24651 DS_ID:22124 EP_NO: N/A Repair Type: Non-Urgent Crossing Status: Found UCIP Comments: 10/27/2017 This structure is inspected annually under the Structure and Channel Summer Inspection (part of the Levee Inspection Program) conducted by the DWR Flood Project Integrity and Inspection Branch (FPIIB). (DWR UCIP - O. Magana) 11/06/2013 - working during field inspection.- blocked siphon breaker. (P. Amatya - DWR UCIP) FIELD_STRUCT_DESC: 1 of 2: 16-inch steel drainage discharge pipe through the levee, 3.5 feet below the crown. Siphon breaker in a corrugated metal pipe (CMP) riser on the waterside (WS) slope. Flap gate on the WS end. Pump on a timber pile structure on the landside (LS). Timber walkway from levee to pump structure. [Additional Reference(s): DWR Levee Log, 1992. USACE San Joaquin O&M Manual 6, September 1961, (HLM 8.60)]. FS Date: 11/6/2013

WS view: two siphon breakers in CMP risers on levee slope.

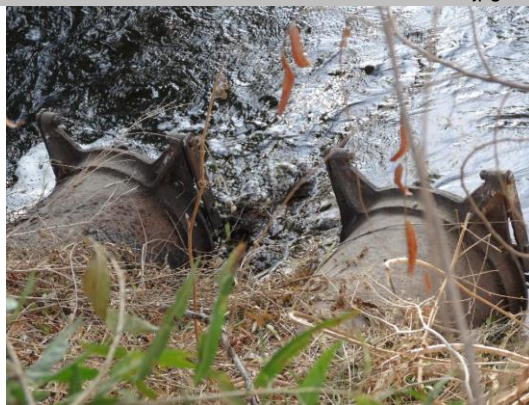
Photo 2 of 3 : UCIP\_SP\_2019\_24651\_44004.jpg

WS view: two flap gates on outfall pipe ends.

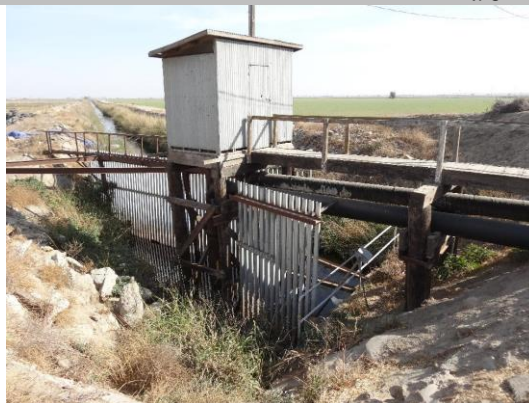
Photo 3 of 3 : UCIP\_SP\_2019\_24651\_44003.jpg

LS view: pipes under walkway to pump house.

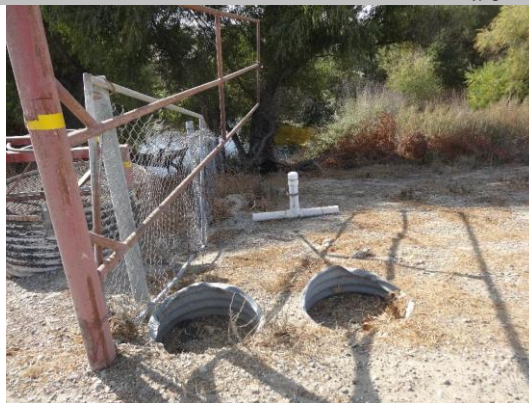
Photo 1 of 3 : UCIP\_SP\_2019\_24652\_44008.jpg

Comment Code						
Inspector Comment						
FS_ID:24652 DS_ID:22112 EP_NO: N/A Repair Type: Non-Urgent Crossing Status: Found UCIP Comments: 10/27/2017 This structure is inspected annually under the Structure and Channel Summer Inspection (part of the Levee Inspection Program) conducted by the DWR Flood Project Integrity and Inspection Branch (FPIIB). (DWR UCIP - O. Magana) 11/06/2013 - working during field inspection.- blocked siphon breaker. (P. Amatya - DWR UCIP) FIELD_STRUCT_DESC: 2 of 2: 16-inch steel drainage discharge pipe through the levee, 3.5 feet below the crown. Siphon breaker in a corrugated metal pipe (CMP) riser on the waterside (WS) slope. Flap gate on the WS end. Pump on a timber pile structure on the landside (LS). Timber walkway from levee to pump structure. [Additional Reference(s): DWR Levee Log, 1992. USACE San Joaquin O&M Manual 6, September 1961, (HLM 8.60)]. FS Date: 11/6/2013

WS view: two siphon breakers in CMP risers on levee slope.

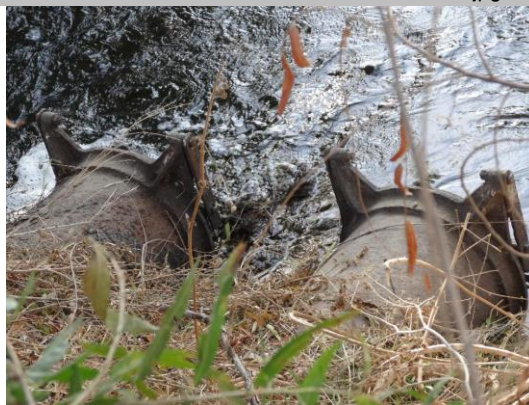
Photo 2 of 3 : UCIP\_SP\_2019\_24652\_44007.jpg

WS view: two flap gates on outfall pipe ends.

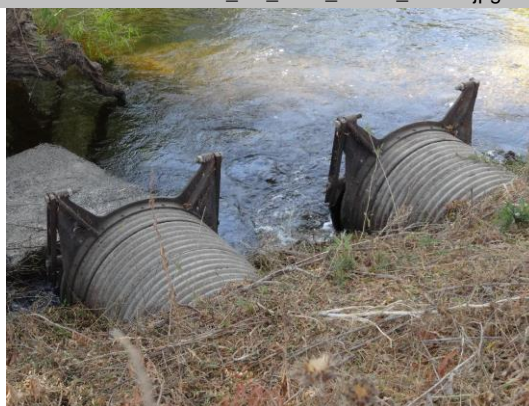
Photo 1 of 3 : UCIP\_SP\_2019\_24650\_44002.jpg

Comment Code						
Inspector Comment						
FS_ID:24650 DS_ID:22113 EP_NO: N/A Repair Type: No Action Needed Crossing Status: Found UCIP Comments: 10/27/2017 This structure is inspected annually under the Structure and Channel Summer Inspection (part of the Levee Inspection Program) conducted by the DWR Flood Project Integrity and Inspection Branch (FPIIB). (DWR UCIP - O. Magana) 11/06/2013 Working during field inspection. (P. Amatya - DWR UCIP) FIELD_STRUCT_DESC: [Reclamation District No. 2063 Pumping Plant] 1 of 2: 42-inch corrugated metal gravity drainage pipe through the levee, 18 feet below the crown. Slide gate in a corrugated metal pipe (CMP) riser on the waterside (WS) slope. Flap gate, concrete saddle, and apron on the WS end. Concrete headwall on the landside (LS) end. [Additional Reference(s): DWR Levee Log, 1992. USACE San Joaquin O&M Manual 6, September 1961, (HLM 8.60)]. FS Date: 11/6/2013

WS view: two flap gates on outfall pipe ends.

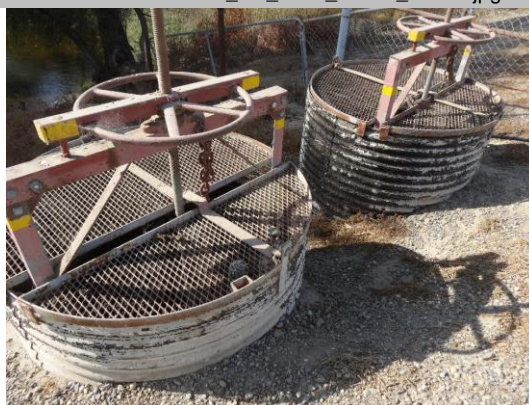
Photo 2 of 3 : UCIP\_SP\_2019\_24650\_44001.jpg

WS view: two slide gates in CMP risers on levee slope.

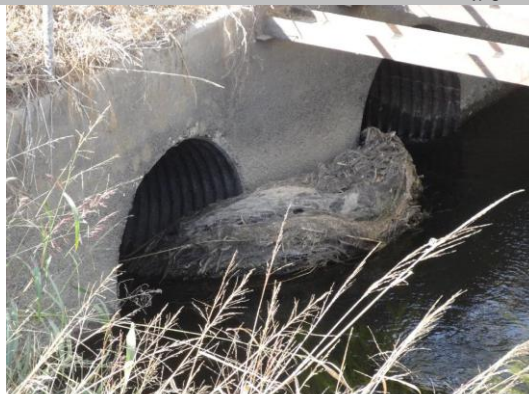
Photo 3 of 3 : UCIP\_SP\_2019\_24650\_44000.jpg

LS view: drainage pipes under walkway in drainage ditch.

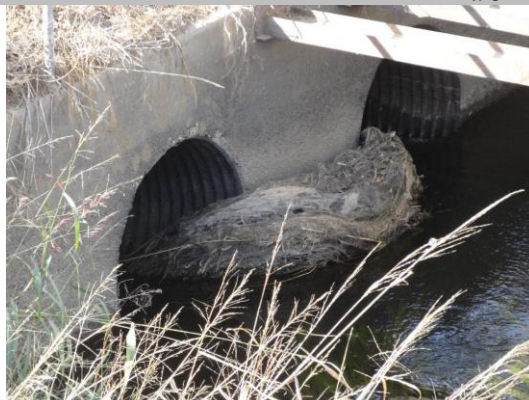
Photo 3 of 3 : UCIP\_SP\_2019\_24636\_43963.jpg

LS view: drainage pipes under walkway in drainage ditch.

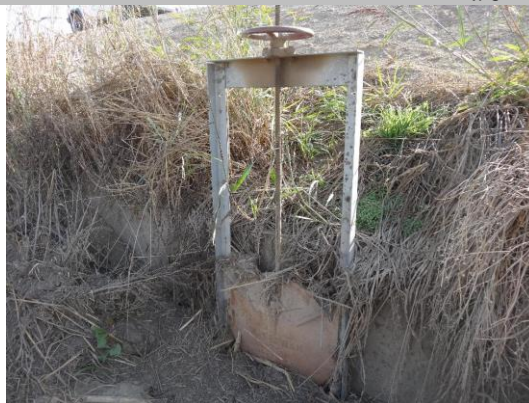
Photo 1 of 2 : UCIP\_SP\_2019\_24638\_43967.jpg

WS view: concrete headwall on levee end. Slide gate on pipe end.

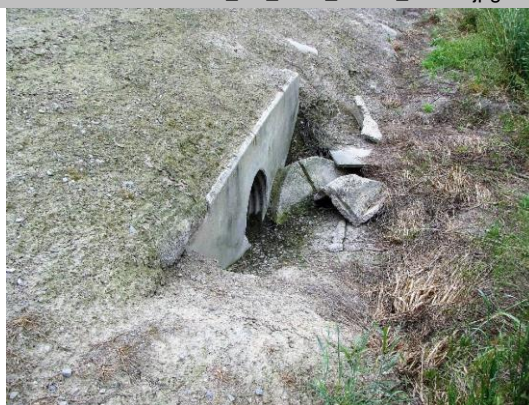
Photo 1 of 3 : UCIP\_SP\_2019\_51825\_77044.jpg

LS inlet as of 4/11/2017 levee inspection. Photo courtesy of DWR inspector Richard Willoughby.

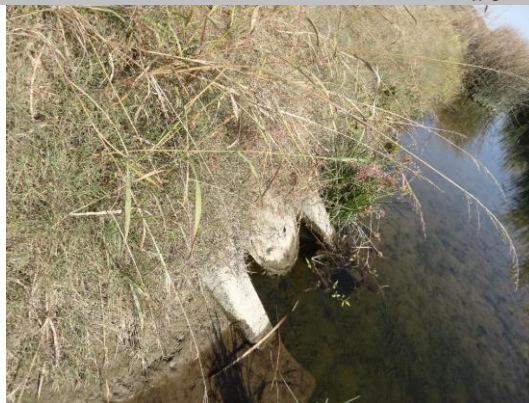
Photo 2 of 3 : UCIP\_SP\_2019\_51825\_43983.jpg

WS view: U type headwall and flap gate visible on the bank of the water channel.

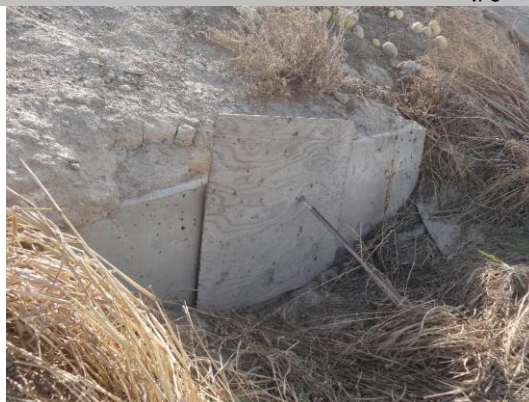
Photo 3 of 3 : UCIP\_SP\_2019\_51825\_43982.jpg

LS view: concrete headwall on levee end. Pipe opening blocked by plywood.

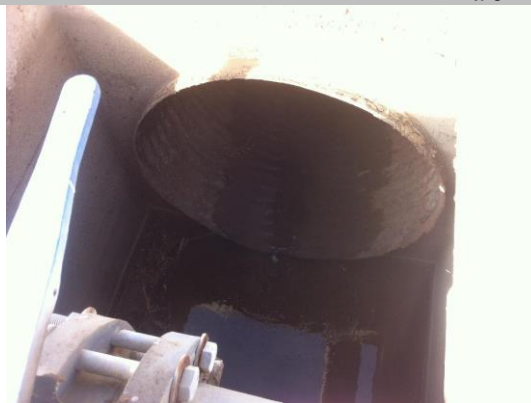
Photo 1 of 3 : UCIP\_SP\_2019\_24644\_43986.jpg

WS view: CM pipe on outlet concrete box.

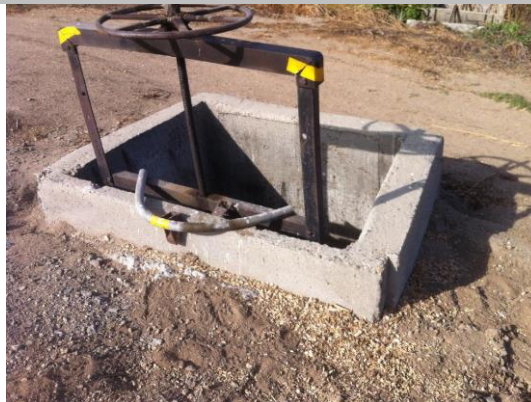
Photo 2 of 3 : UCIP\_SP\_2019\_24644\_43985.jpg

LS view: CM pipe with slide gate on inlet concrete box.

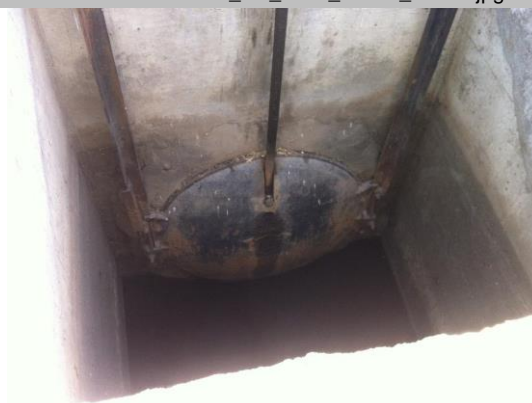
Photo 3 of 3 : UCIP\_SP\_2019\_24644\_43984.jpg

LS view: inside view of slide gate in concrete box.

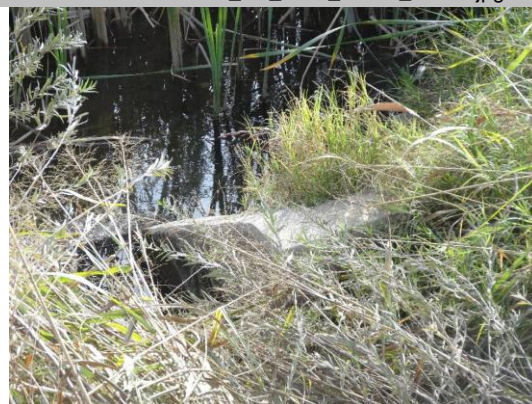
Photo 1 of 2 : UCIP\_SP\_2019\_24645\_43988.jpg

WS view: concrete U type headwall on channel bank. Not accessible.

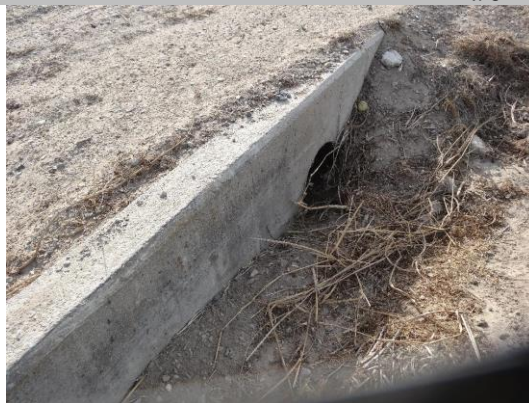
Photo 2 of 2 : UCIP\_SP\_2019\_24645\_43987.jpg

LS view: concrete headwall and partially blocked inlet opening.
